Microbiologically Influenced Corrosion

The U.S. Environmental Protection Agency (EPA) has released the results of a 2015 study on the ultra-low sulfur diesel (ULSD) fuel conducted to attempt to determine what is causing the corrosion fouling issues associated with ULSD USTs.

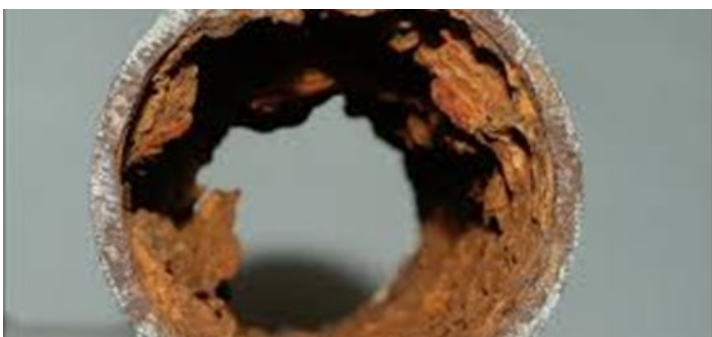
Although the EPA acknowledges from the beginning of its study that this research is still too limited to determine a definitive cause for accelerated microbial growth, it does confirm that, "MIC [microbiologically influenced corrosion] is likely playing a major role in the corrosive environments in USTs storing diesel."

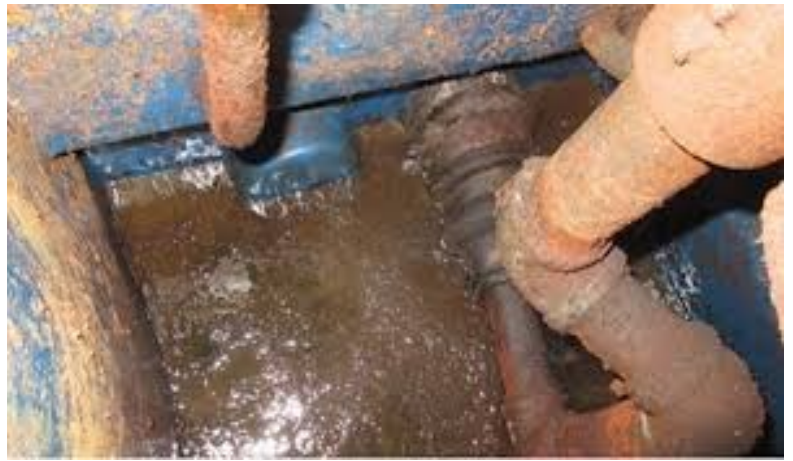
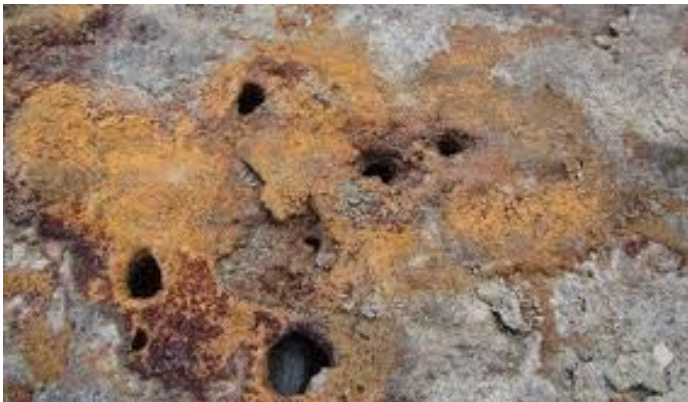
Accelerated corrosion occurrences primarily in submersible turbine pumps, drop tubes, sensor probes and dispenser components. Corrosion occurring in systems storing and dispensing ULSD is likely due to the dispersal of acetic acid throughout USTs. The acetic acid is likely produced by bacteria feeding on low levels of ethanol contamination. Dispersed into the humid vapor space by the higher vapor pressure and by disturbances

during fuel deliveries, acetic acid is deposited throughout the UST system. This results in a cycle of wetting and drying of the equipment which concentrates the acetic acid on metallic equipment causing severe and rapid corrosion. Contamination may be occurring in pipelines, terminal systems, cargo tank compartments or manifold vent systems.

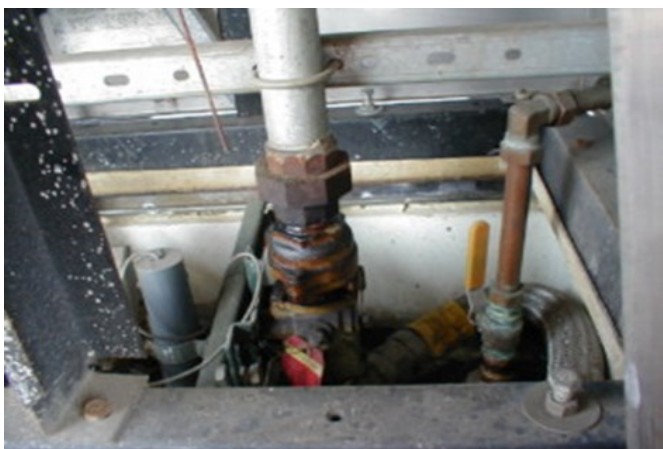
Dissolving plastics and creating deposits

Ethanol is an excellent solvent and drying agent that dissolves old gum and varnish deposits from the gas tank and fuel lines. However, it can also dissolve plastic and create deposits.
